File OF-Surv-Inc 2008-030  
13 February 2009

**Report Issued by the National Energy Board February 2009 entitled *Investigation under the National Energy Board Act into the Death of Mr. Henri St. Pierre at the Enbridge Pipelines Inc. Kerrobert Pump Station on 24 March 2008***

The Enbridge Southern Access Expansion project stages 2A and 2B (Project) were approved by Board Order XO-E101-01-2007 on 25 January 2007. The Project includes the upgrade of four mainline pumps and the addition of one booster pump at the Enbridge Kerrobert pump station. As part of the Kerrobert station pump upgrades, the Unit 4-U-3 pump was to be replaced by a unit with higher horsepower. Prior to removing the Unit 4-U-3 pump, it first needed to be electrically isolated by racking out (switching off) the unit from the 4160 volt power supply and then grounding to eliminate any residual electricity that may be present in the unit. Prior to racking out, the electrical equipment within any of the power factor capacitor cells in use in 4-ESB-1 would be electrically live, carrying 4160 volts. Racking out and grounding was to be conducted by Enbridge electricians on 24 March 2008 from within building 4-ESB-1.

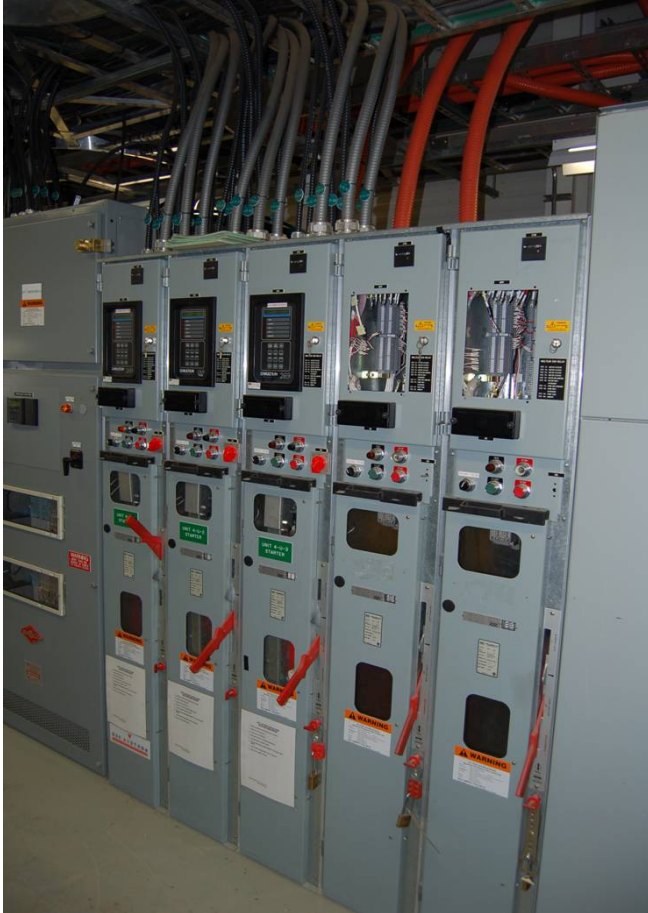
Photo 5.1 shows the bank of five unit starters left undisturbed immediately following the incident as required by section 127(1) of the CLC. The unit starters are numbered from 4-U-1 to 4-U-5 in sequence from left to right. The photo shows that starters 4-U-2 and 4-U-3 are in the racked out position (indicated by the red levers in the down position). A lock is applied to starter 4-U-3; however a lock is not applied to starter 4-U-2 due to the emergency nature of racking out this starter immediately following the incident. Starters 4-U-4 and 4-U-5 are extra starters, which were not in use and not connected to equipment at the time of the incident.

Photo 5.1: Unit starters located in 4-ESB-1 building.

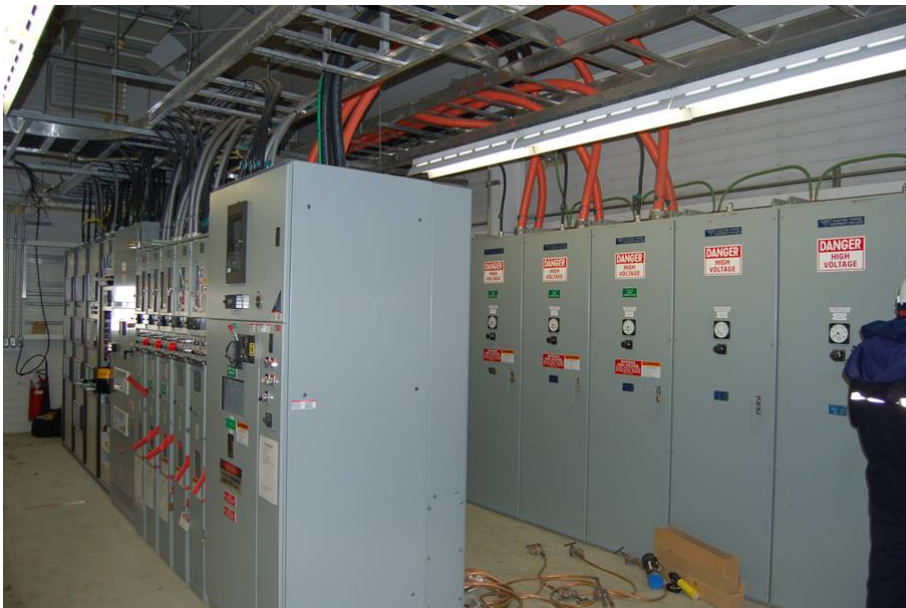
Photo 5.2 shows the relative positions of the five unit starters (left) and the five power factor capacitor cells (right). The grounding cables in use at the time of the incident can be seen lying on the floor in front of the power factor capacitor cells. Also seen in the photo is the overhead lighting that was used by Mr. Halter to test the function of the voltage probe prior to conducting a sweep inside the cell with the probe.

Photo 5.2: Unit starters and power factor capacitor cells.

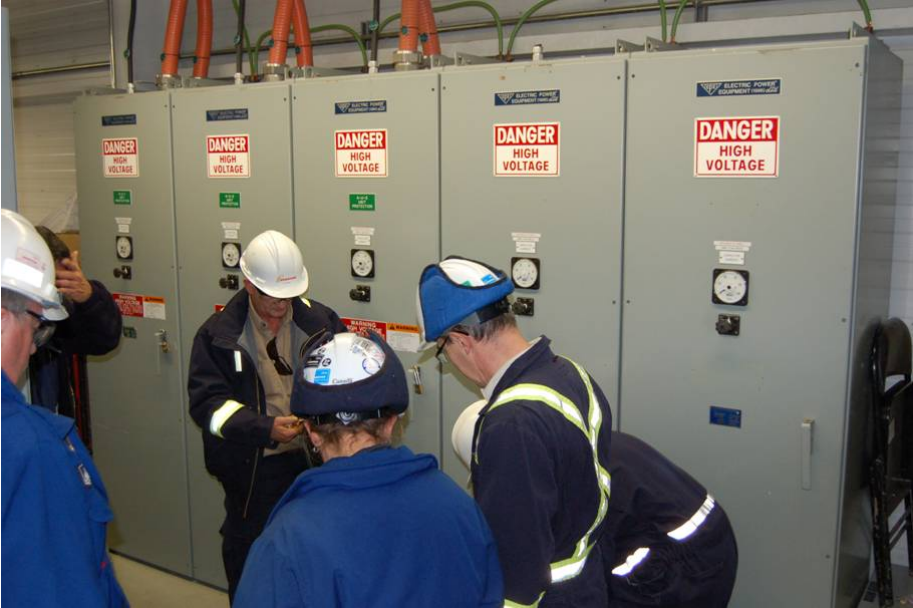
Photo 5.3 shows the bank of five power factor capacitor cells. The power factor capacitor cells are numbered from 4-U-1 to 4-U-5 in sequence from left to right.

Photo 5.3: Power factor capacitor cells.

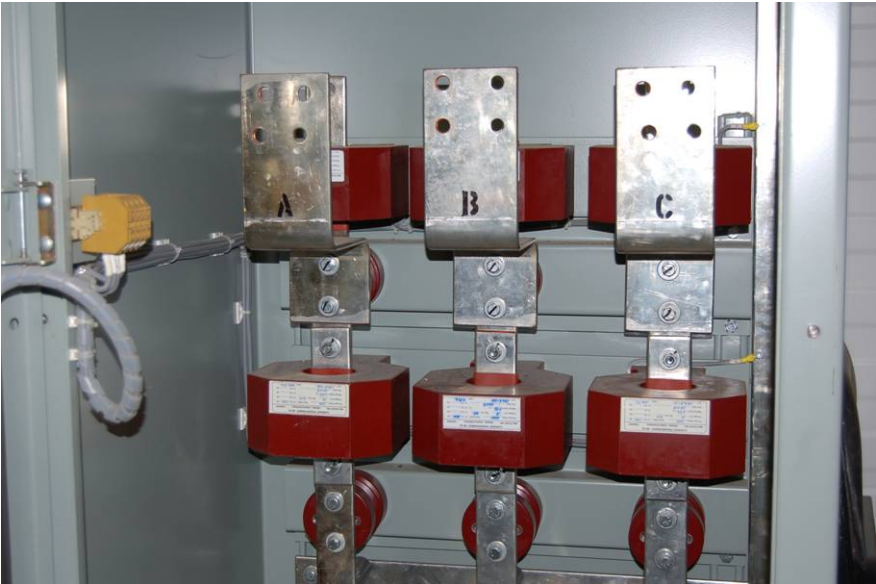
Photo 5.4 shows the inside of power factor capacitor cell 4-U-2. The metal bus bars are labeled A, B and C. After racking out the unit, grounding is accomplished by connecting the three tail ends of the grounding cables to the three bus bars and then the lead end of the grounding cables to a ground point.

Photo 5.4: inside of power factor capacitor cell 4-U-2.

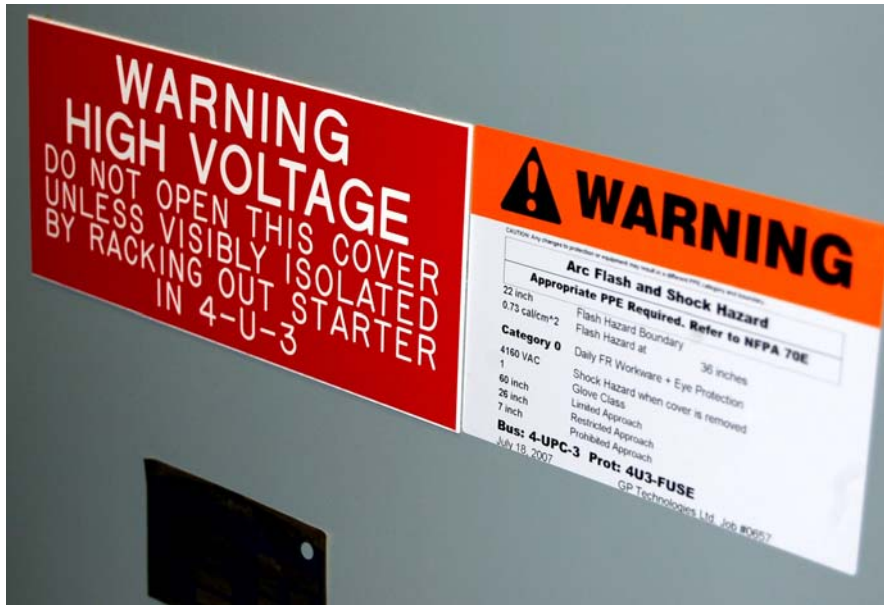
Photo 5.5: Warning labels on outside of door to power factor capacitor cell 4-U-3. The labeling is common to all power factor capacitor cells in 4-ESB-1.

The Board notes that Enbridge has assigned flash hazard number HRC-0 to the power factor capacitor cells in the Enbridge 4-ESB-1 building (photograph 5). The Board also notes the requirements of NFPA 70E to conduct a Shock Hazard Analysis, a Flash Hazard Analysis and, through calculations provided in Annex D, to determine Flash Protection Boundaries and incident energy exposure of a worker. However, these calculations do not determine a HRC number for flash protection. The standard allows for determination of the HRC number and PPE requirements using section 130.7(C)(9) in lieu of the detailed flash hazard analysis approach.

The Board notes that in addition to the HRC-0 flash hazard indicated on the warning labels to the power factor capacitor cells, there is reference to Glove Class 1. The Board interprets this sign to mean that gloves are required to be worn regardless of the PPE requirements indicated by HRC-0. The Board finds this may cause confusion for workers as the HRC-0 does not require high voltage gloves to be worn, but the Glove Class 1 is indicated. The Board also notes that the warning label warns specifically against “Arc Flash and Shock Hazard”, however, the PPE requirements of HRC-0 would not be sufficient to protect against the arc flash and shock hazard

- Demonstrate how the Hazard/Risk Category number 0 was determined for the power factor capacitor cells in 4-ESB-1.
- Re-assess the Hazard/Risk Category number assigned to the cells.
