**Investigation under the *National Energy Board Act*
In the Matter of: 9 July 2006 ruptures of the Pine River Gas Plant Sulphur Pipeline,
owned and operated by Westcoast Energy Inc. carrying on business as Spectra
Energy Transmission (Spectra)**

9 July 2006 ruptures of the Pine River Gas
Plant Sulphur Pipeline, owned and operated by
Westcoast Energy Inc. carrying on business as
Spectra Energy Transmission

June 2009

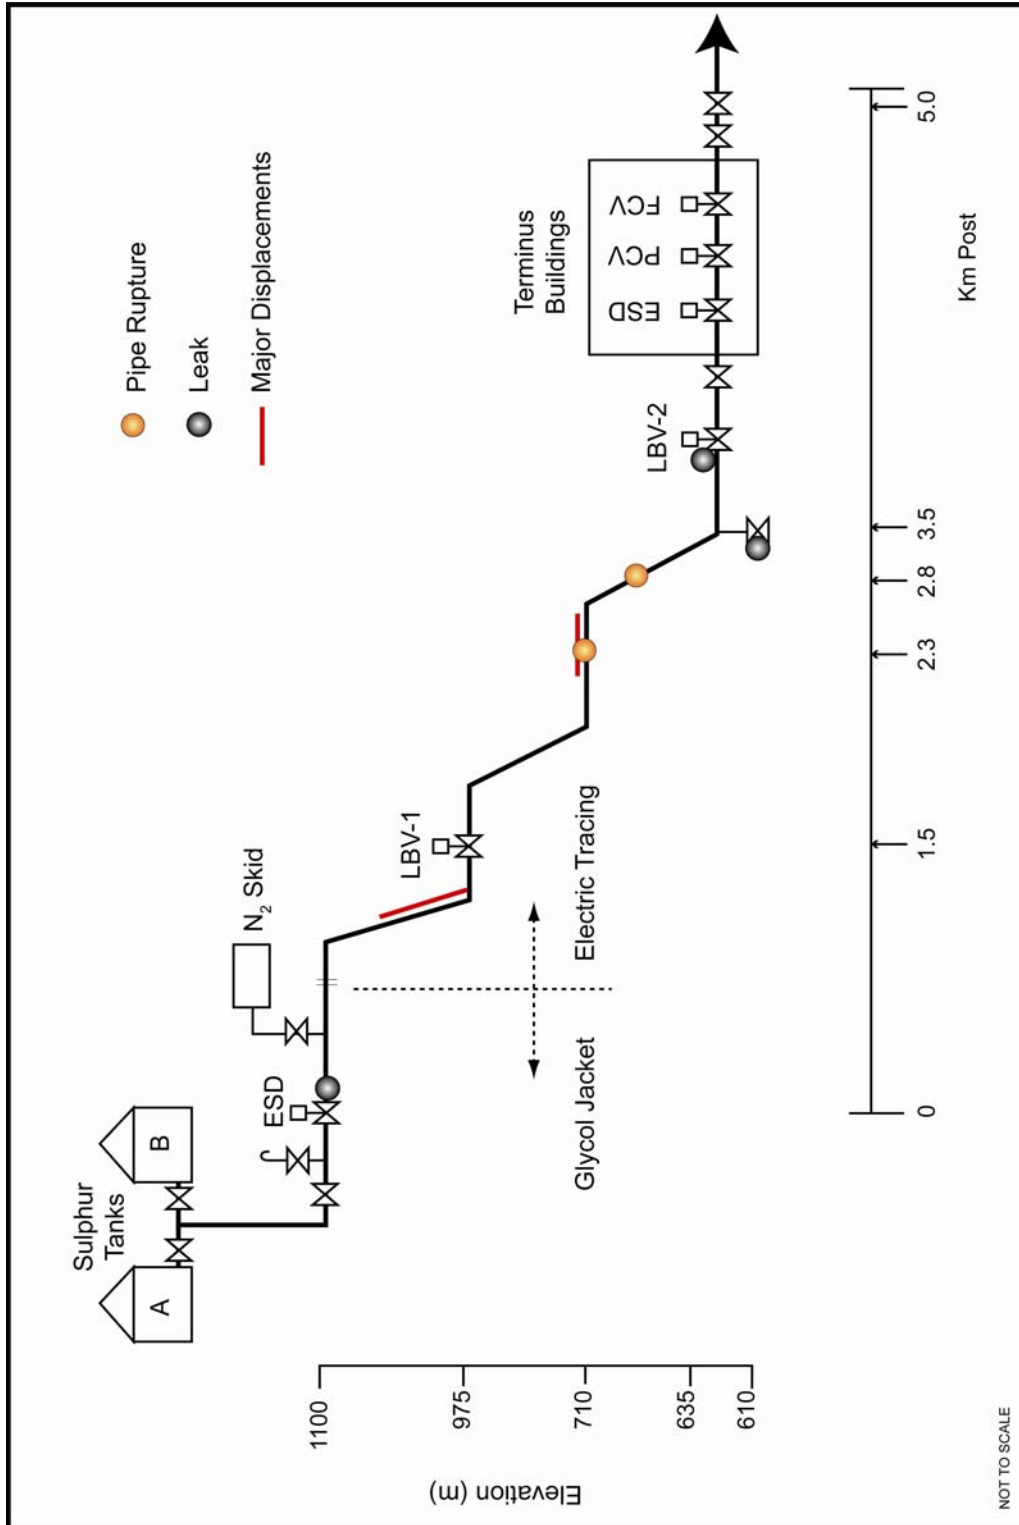
Schematic Diagram of Sulphur Pipeline Damages

The sulphur pipeline sustained ruptures at 2.3 km and 2.8 km, as well as damaged anchors and displacement of the pipe from its supports at 1.5 km, 2.3 km, and 2.8 km. The condition of the pipe was examined by removing insulation at piles along the pipeline. Measurements confirmed the pipeline had expanded in diameter by as much as 3.8% near the 2.3 km rupture and 5.7% downstream of the 2.8 km rupture⁶. The rupture at 2.3 km occurred on the inside radius of the last 90 degree elbow of an expansion joint. The anchors were damaged and the pipe was completely displaced from its supports. The rupture at 2.8 km occurred on a straight section of pipe located on a slope. Pipe at this location was displaced on its supports.

Spectra repaired all damaged anchors, tie-rods, supports and shoes prior to returning the sulphur pipeline to service. Spectra and its consultants reviewed design of anchor and tie-rod assemblies and determined that the design is acceptable for foreseeable operational dynamic events related to normal operation.

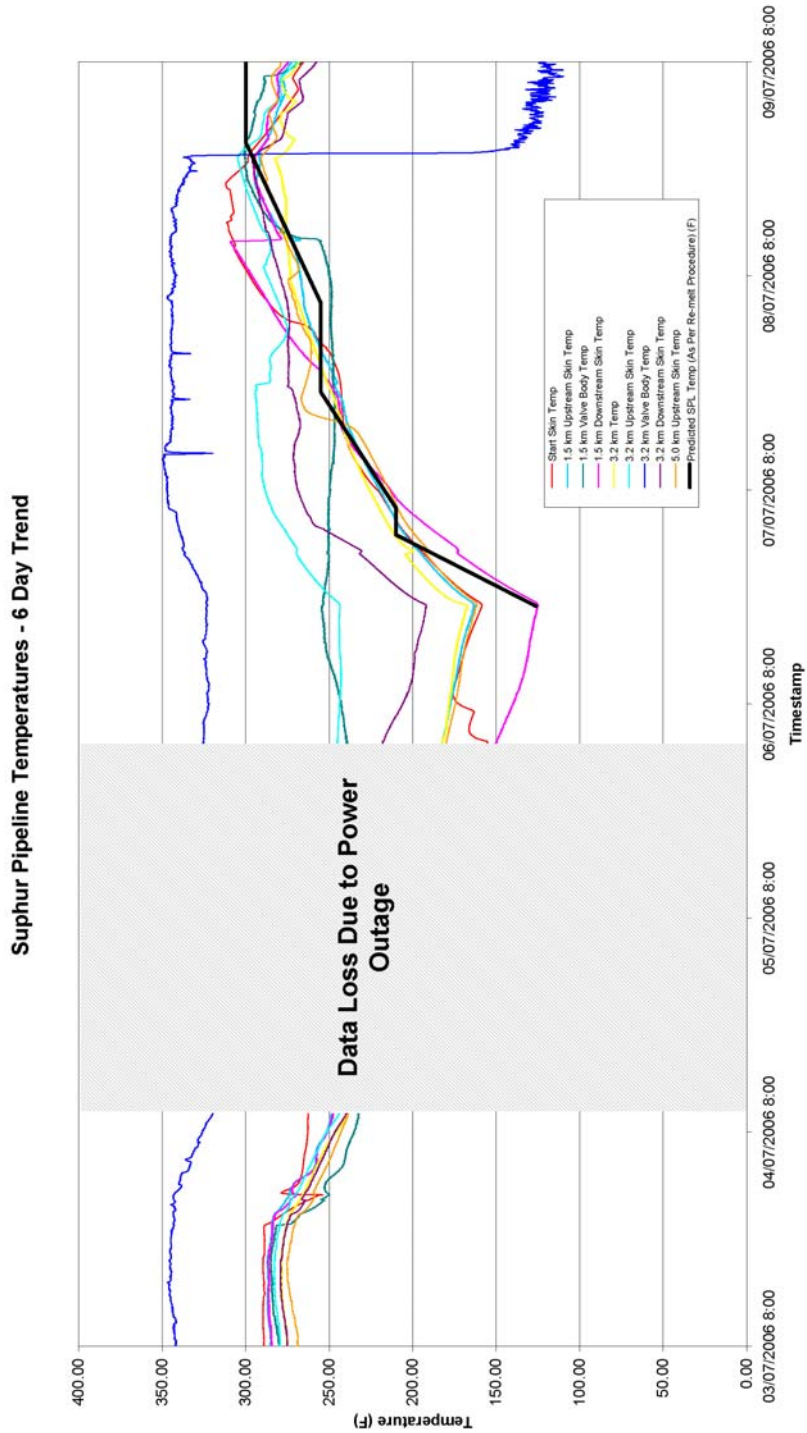
Sulphur Pipeline Time-Temperature Profile

In practice however, when the remelt procedure was initiated upon restoration of power, the controlled temperature increases and hold periods could not be achieved (the time-temperature profile is provided in Appendix VI). The uneven heating observed during the remelt procedure may have been a result of initiating the procedure when: temperatures varied greatly throughout the pipeline (between 52°C and 163°C); sulphur in the pipeline was at varying degrees of solidification; sulphur plugs and voids were present; there were heat sinks at discontinuities in the pipeline; or any combination thereof. Ultimately, the remelt procedure was unsuccessful and resulted in uneven temperatures and overpressure conditions that eventually ruptured the sulphur pipeline.

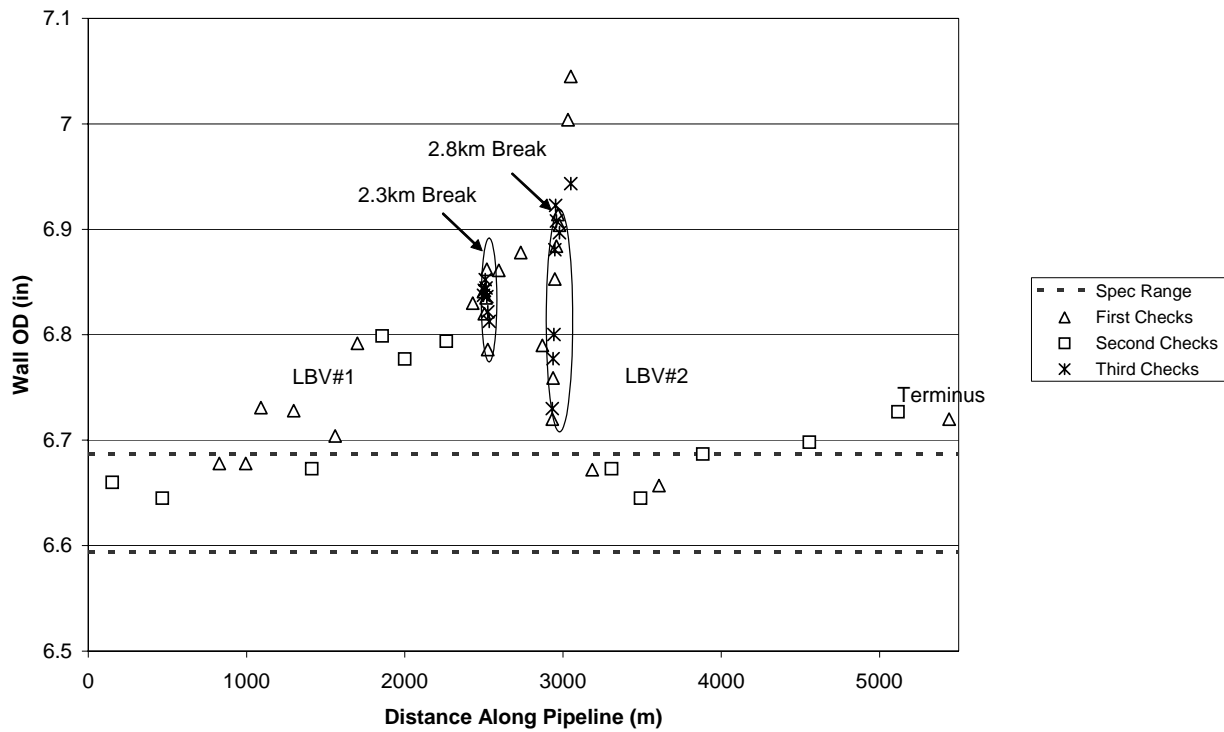
Figure VII-1: Sulphur Pipeline Outside Diameter Measurements

The results of measurements along the sulphur pipeline are compiled in two plots, provided in Appendix VII. Measurements of the outside diameter were plotted against distance in Figure VII-1, with the range of specification ASTM A 106 for comparison. Expansion proved to be greatest in locations near the 2.3 km and 2.8 km ruptures and exceeded the range of the specification. Measurements of the wall thickness were also plotted against distance in Figure VII-2, with minimum and nominal wall thickness of specification ASTM A 106 for comparison. All wall thickness measurements were greater than the minimum specified by ASTM A 106.
